TREE SURVEY & CONDITION AND MANAGEMENT REPORT

OUR REF: GD/17028/R/sh

DATE: 7th August 2017

SITE ADDRESS: Tidenham Parish
Selected Sites

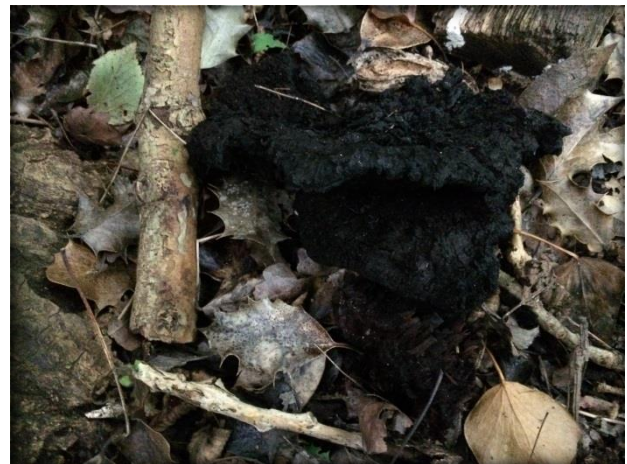
The presence of a desiccated fungal fruiting body suspected to be Shaggy Polypore (*Inonotus hispidus*) was found detached at the base of T285 & T286.

This fungus develops an annual fleshy bracket, orangey-brown when fresh, quickly degrading as it reaches maturity, developing a black spongy bracket before detaching.

The type of decay is also classed as a simultaneous 'white rot' attacking both cellulous and lignin at a similar rate.

The pathogen enters the tree through wounds on the branches or the main stem and decomposes the heartwood. It can cause bark death, and causes the timber to become brittle. This can lead to fractures of the affected branches and stems.

Figure 6. showing the *Inonotus hispidus* fungal fruiting body detached at the base of T286 & T287

The report identified two Ash trees (T285 & T286) as showing signs of decline with decay at base and a number of fruiting bodies identified as *Inonotus hispidus* found on ground at the base of both trees. For this reason it is recommended that both trees are reduced to a standing stem (monolithic) height of 5.0 metres above ground and retained for habitat.
