Tree Survey Condition & Management Report

Various Site Locations: Tidenham – Sedbury – Tutshill - Beachley

Wednesday 29th July, Thursday 30th July & Monday 3rd August 2020

Tidenham Parish Council
Hang Hill Road
Bream
Lydney
GL15 6LQ

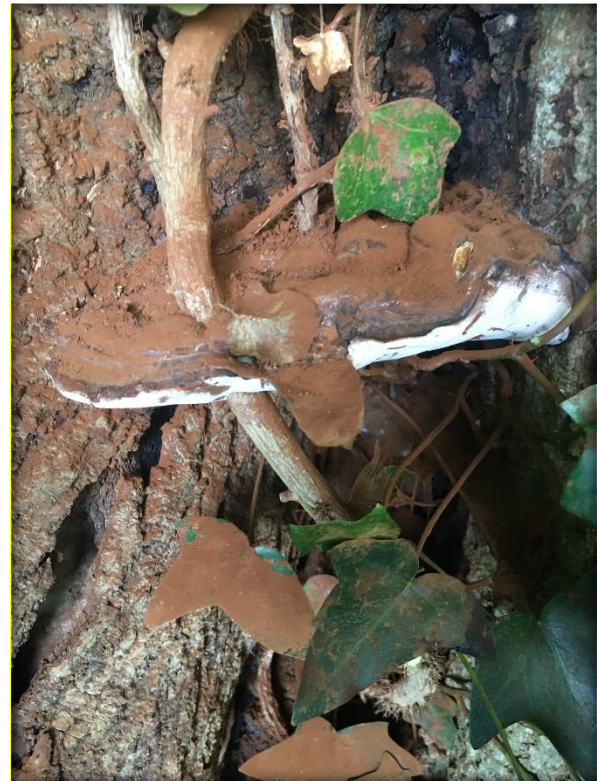
The presence of a fungal fruiting body suspected to be *Ganoderma Applanatum* (*Artist Pallet Fungus*) was found attached to the lower stem of the third party Common Ash T266.

Type of Decay: The fungus causes a white rot (preferential lignin decomposition) commonly associated with dysfunctional xylem

Area affected: The fungus is predominantly associated with decay of the base or lower stem although occasionally found at height.

Consequence: When extensively decayed can lead to a ductile fracture resulting ultimately in failure and wind-throw.

Figure 5, showing the *Ganoderma* fungal fruiting body attached at the base of T266

During the recent inspection multiple Fungal brackets identified as *Ganoderma Applanatum* were observed attached to the eastern quadrant of the main stem indicating internal decay.

The presence of this pathogen is made more concerning by the extent to which the eastern most stem has a significant lean and canopy spread over the site. If failure were to occur significant damage would be caused to the church and graves and more importantly consequence of failure could be severe if people are within the target area.

It has now been recommended that the tree is removed or at very least an in-depth level 3 survey is carried out to determine the extent of internal decay at the base and risk posed.
