Tree Condition Survey & Management Report

Various Locations Within:

- Tidenham
- Sedbury
- Tutshill
- Beachley

CW.230100.R

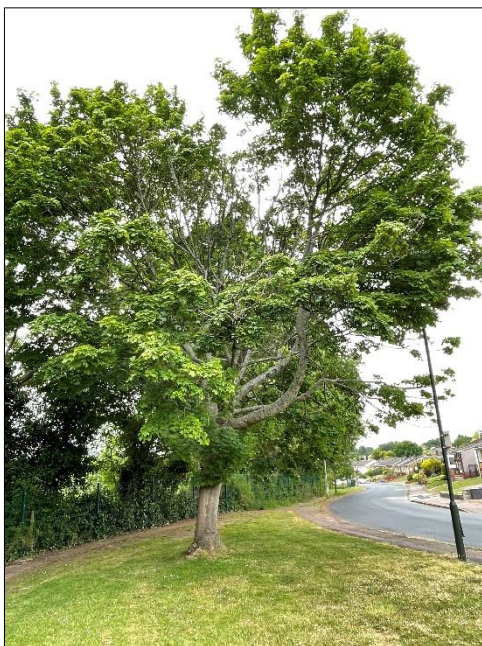
Figure 7: Image of Dead Branches in Norway Maple T264a

Tree No	Species	DBH (mm)	HT (m)	Crown Spread (m)	Age	Vigour	Condition and Observations	Recommendations	Timescale	Risk	Re-Survey
T264a	Norway Maple	490	15	7	EM	Declining	Moderate: . No access for full VTA . Wounding to surface roots with sapwood decay . Minimal wound wood . Multiple pruning wounds on main stem exhibiting sapwood decay and cavity formation . Central leader dead . Southern canopy dieback and decline.	. Remove dead branches . Reduce height of east scaffold limb (into shape with remaining crown)	6 Months	Mod	One year
T265a	Oak	500	15	5	EM	Fair	Good: . No access for full VTA . Ivy and understory vegetation precluded full VTA . Single stem tree . Asymmetrical crown north and west . Reasonable branch structure . Well-formed unions throughout . Tip dieback east	. Remove stubbed branches	2 Years	Low	Three years

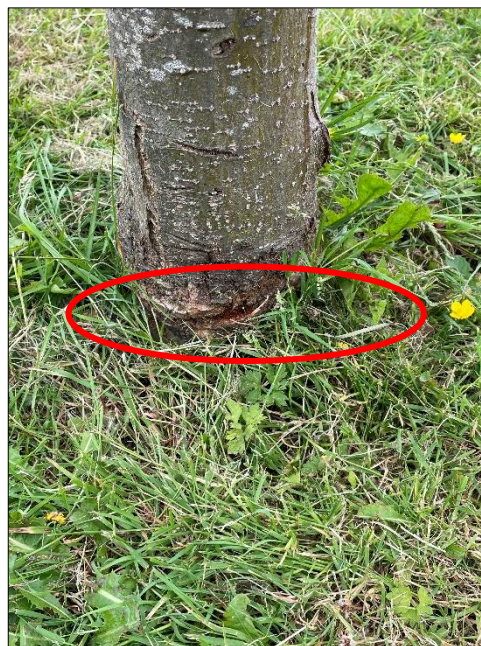
We previously recommended creating mulch rings for the orchard trees, to address the "mower blight" which is affected the surface roots and base of tree stems. This is still an issue in 2023 with all of the tree stems being cut and damaged by mowers as well as strimmers. These trees reflect an investment by Tidenham Parish Council, and this damage will reduce the life expectancy of the trees – if not kill them outright. The creation of mulch rings is a simple and cheap course of action which will not only protect the Council's investment, but improve tree health and vitality.

Figure 8: Image of Strimmer Damage to Orchard Tree
